Dust Sealing Solutions

The Problem

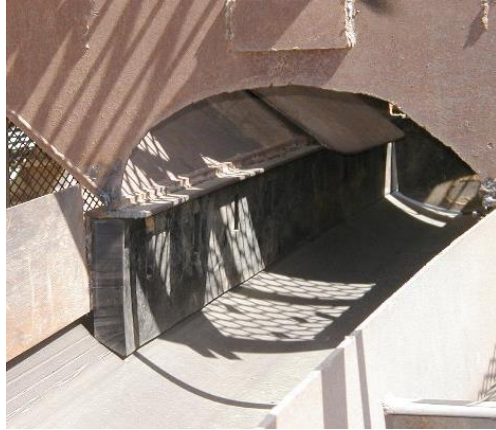
After assessing the situation, GRT Rubber installed 8"x48" Canoe Liners with 1.5" rubber and a ¼" backing plate in the load zone of the transfer point. Canoe Liners reduce abrasion, improve environmental conditions by controlling dust, and lower overall maintenance costs throughout the conveyor system's lifespan. Various Canoe Liner designs, including ceramic options, are available to meet diverse application needs.

Following installation, the Canoe Liners realigned the material to the center of the belt which resulted in immediate improvements including the elimination of dust, spillage, and maintenance issues. The liners have been performing for over 6 months—**more than three times longer than the lifespan of previous skirting solutions.** This success has prompted the operation to explore additional GRT product offerings for future projects.
